MINISTRY OF TRANSPORT

REPORT ON THE DERAILMENT

POLESWORTH

London Midland and Scottish

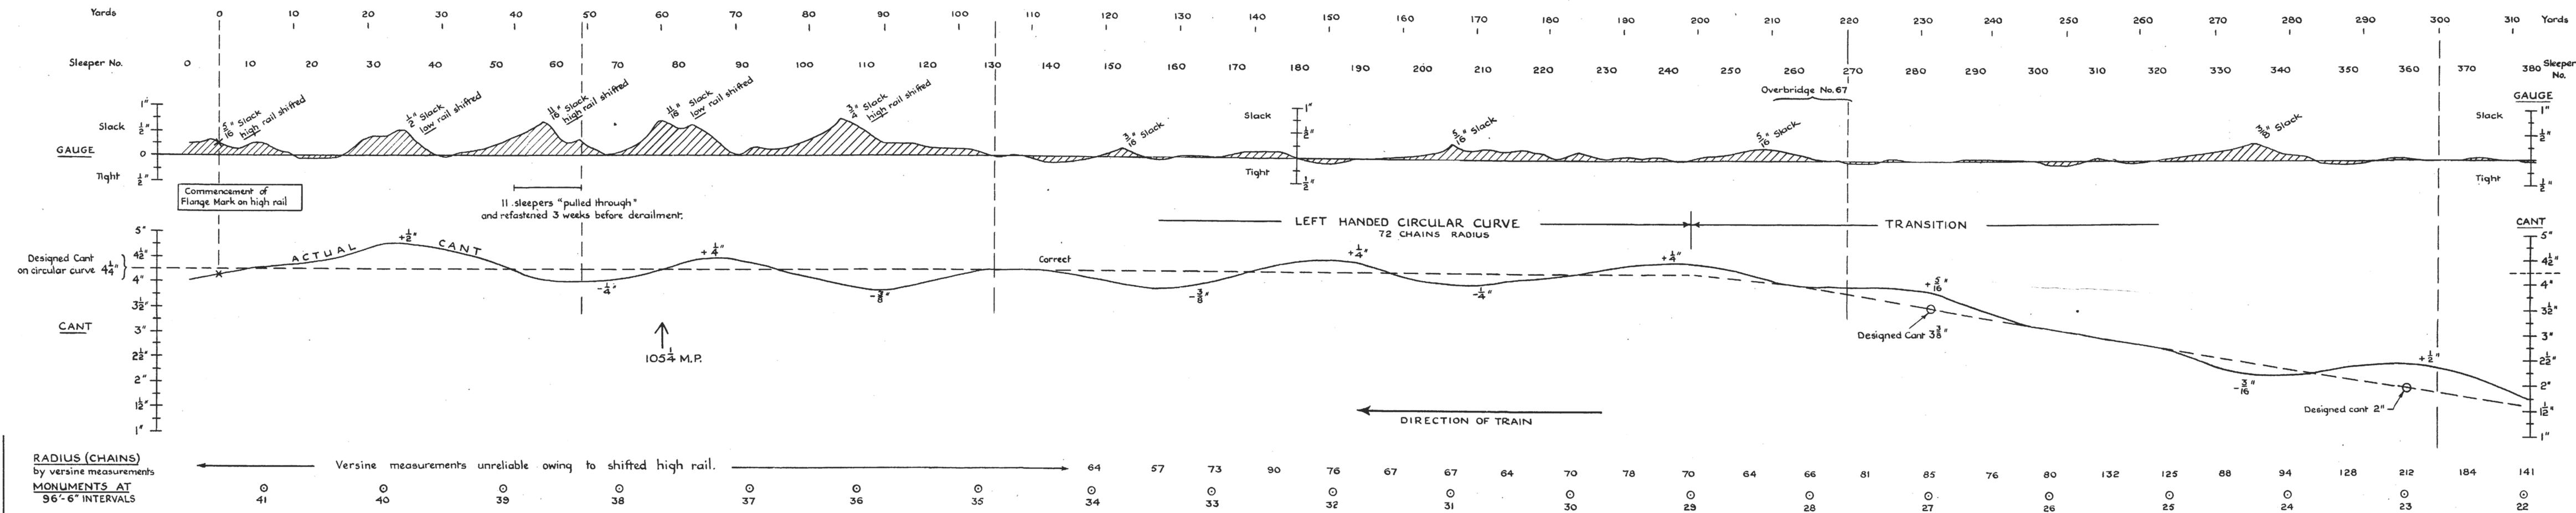
FIG. 5. GAUGE AND CANT DIAGRAM.

7. The actual gauge and cant for over 300 yards in rear of the point of derailment are shown to an exaggerated vertical scale by the diagram Fig. 5, which is based on measurements taken at every sleeper before any repairs had been carried out to the track. From 300 yards in rear to 220 yards, on the transition, there was a length of 20 yards where the gauge was slack to a maximum of $\frac{3}{8}$ inch, with nearly correct gauge on either side. For the next 115 yards (220 yards in rear to 105 yards), at the end of the transition and on the circular curve, there was varying slackness to a maximum of $\frac{1}{8}$ inch, with a few tight places (max. $\frac{1}{8}$ in.). So far, the signs of progressive movement of the chairs on the sleepers were much as might be expected with track nearing the end of its life.

For the last 105 yards, however, the widening of the gauge to a maximum of $\frac{3}{8}$ inch was of quite different character, and had occurred in five clearly defined waves, 60—70 feet apart. The movement was evidently of very recent origin, and the inclination of the coachscrews and the lateral shift of the chairs showed that the high and low rails alternately had been forced from their correct gauge line. Fig. 5 also shows the position of 11 sleepers on which the chairs had been refastened with fresh screw holes three weeks before the derailment, in order to correct slack gauge to the extent of $\frac{1}{8}$ inch.

The maintenance of the cross-level, however, on the transition and on the circular curve left a good deal to be desired, particularly as high and low cant alternated in comparatively regular waves. This is shown by the diagram, Fig. 5, which it will be noted that slack gauge of $\frac{3}{8}$ in. and $\frac{1}{8}$ in. was related to a drop in cant, and in the last 105 yards, the fresh movement of the high and low rails from the gauge line, which has been described, corresponded with remarkable regularity to low and high cant respectively.
