LONDON MIDLAND AND SCOTTISH RAILWAY.

Ministry of Transport,
4. Whitehall Gardens,
London, S.W.1.
7th May, 1935.

L.M. & S.R. ASHCURCH & EVESHAM LINE

DERAILMENT ON FEB. 25TH 1935

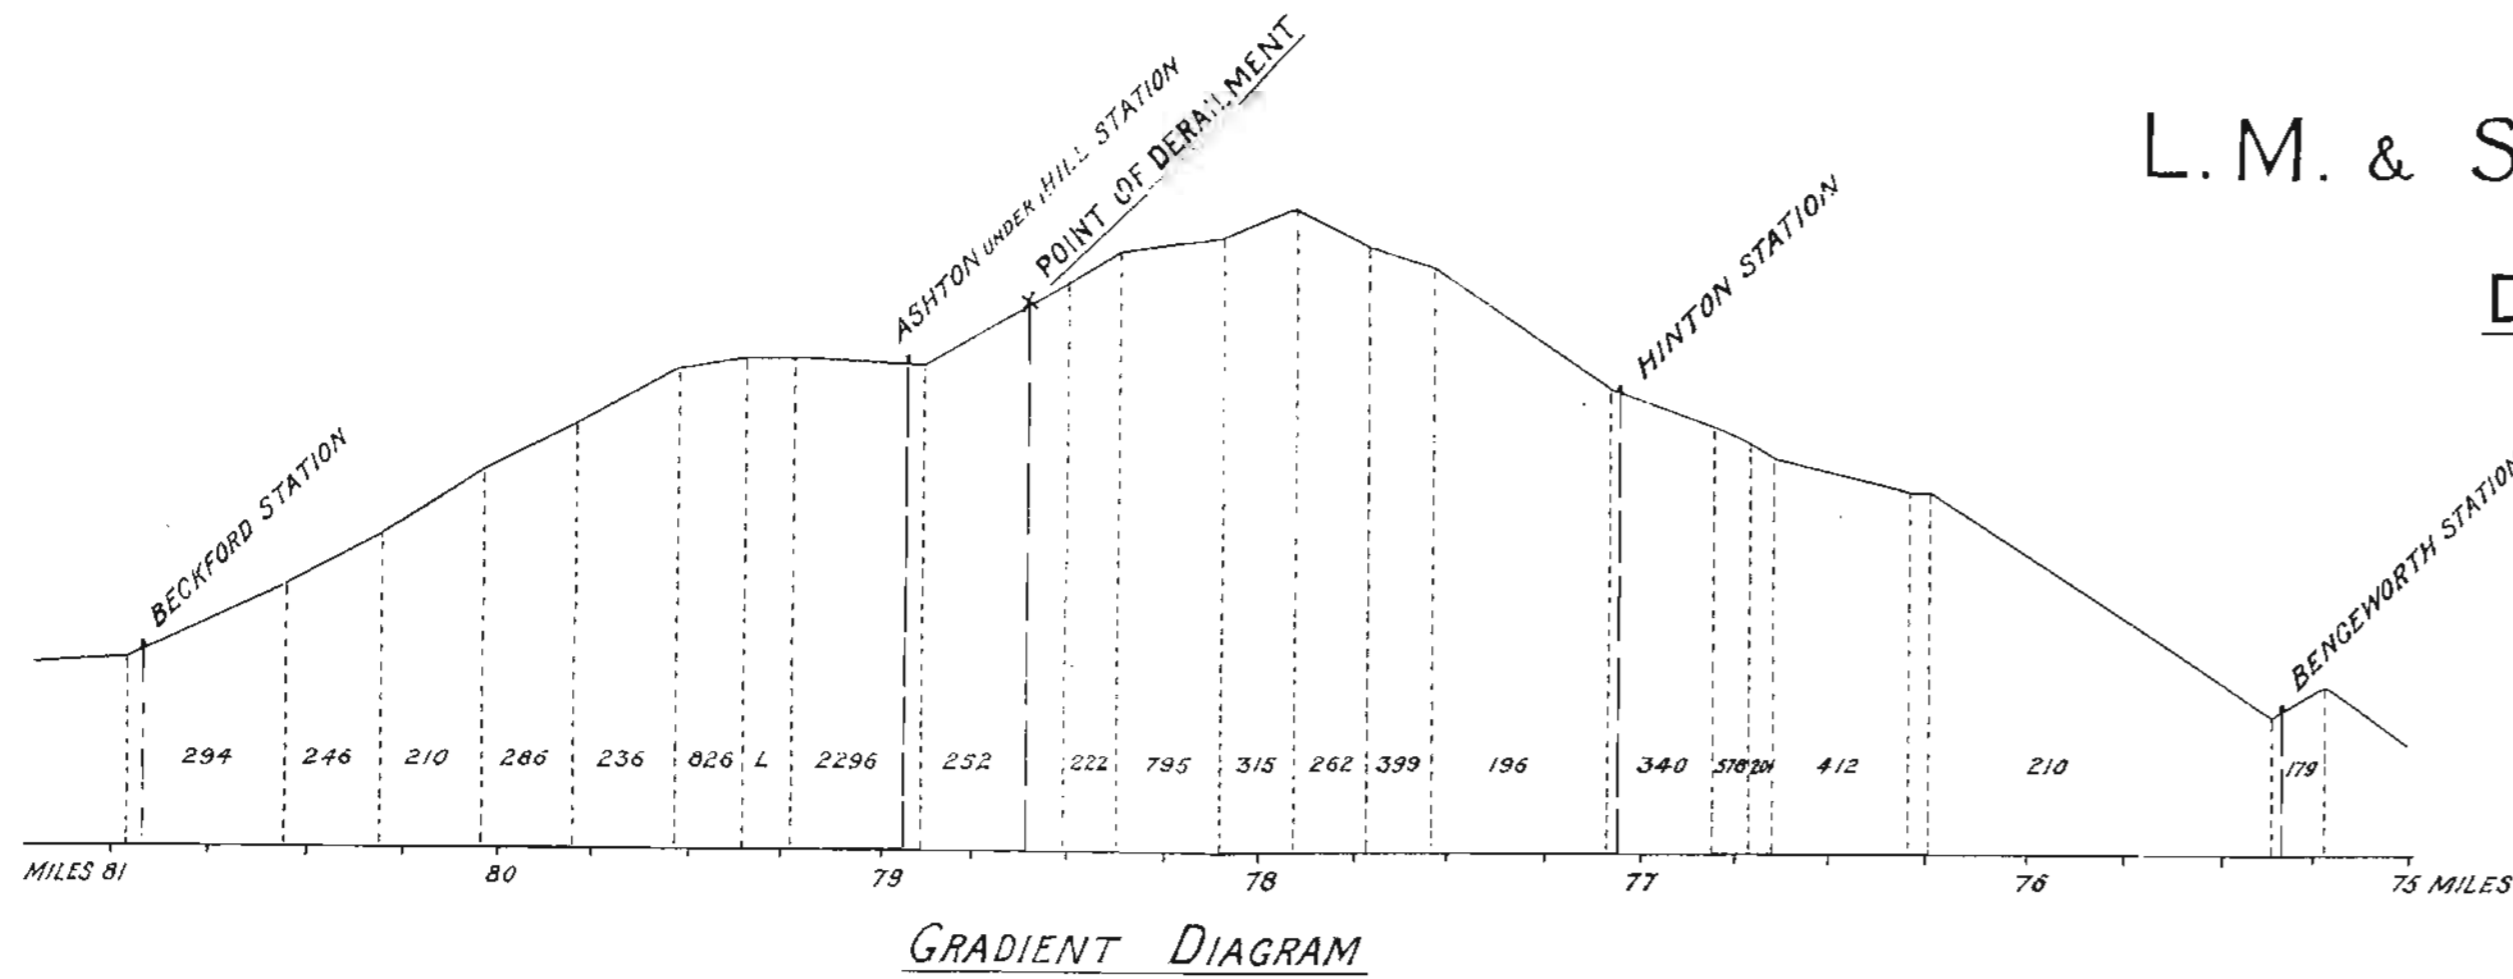
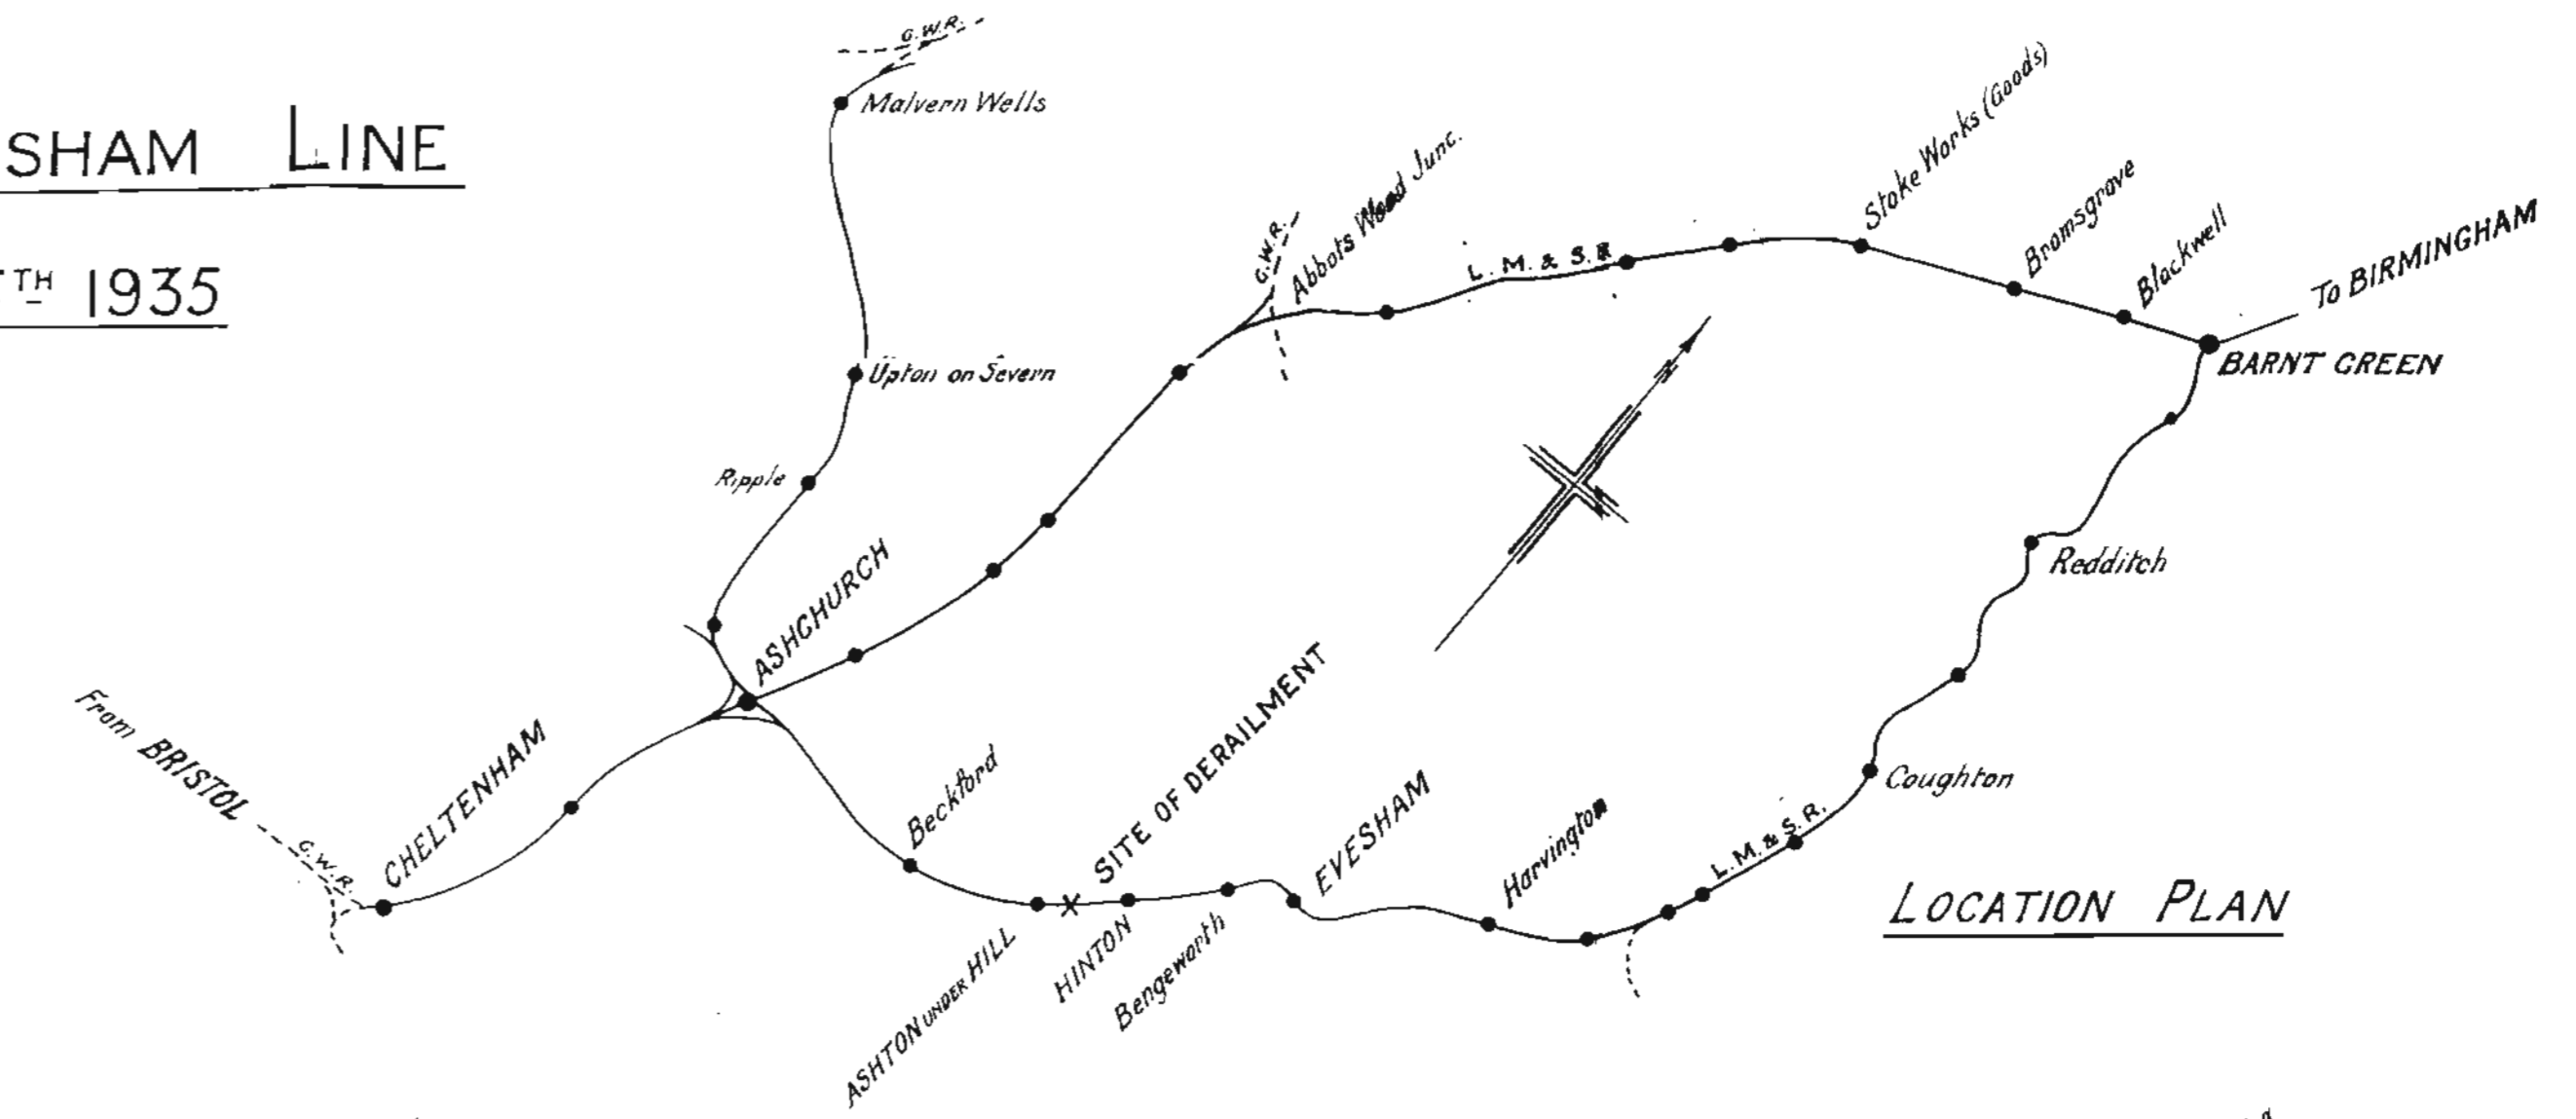
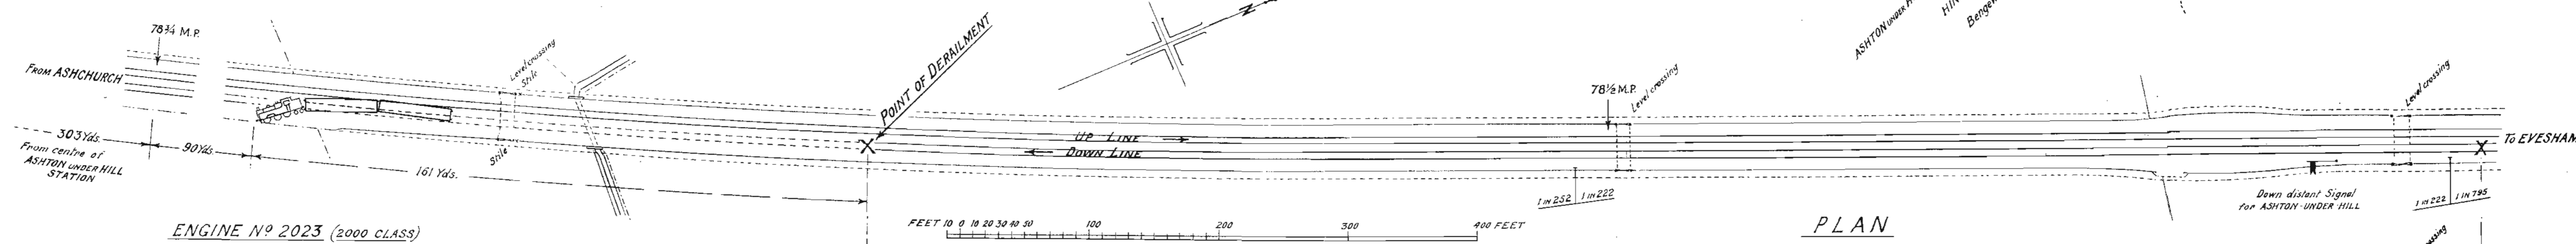
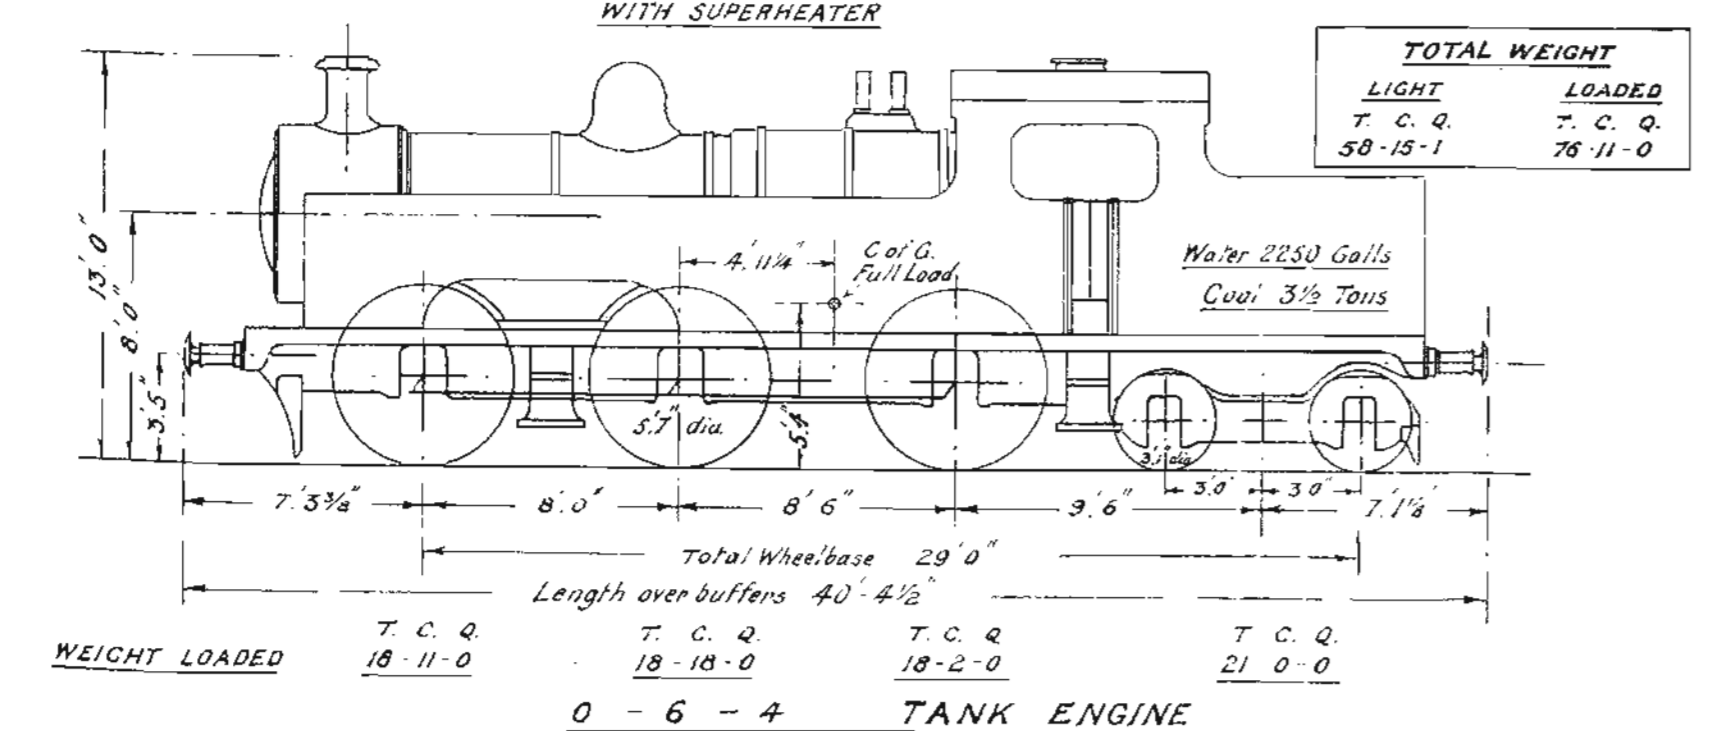
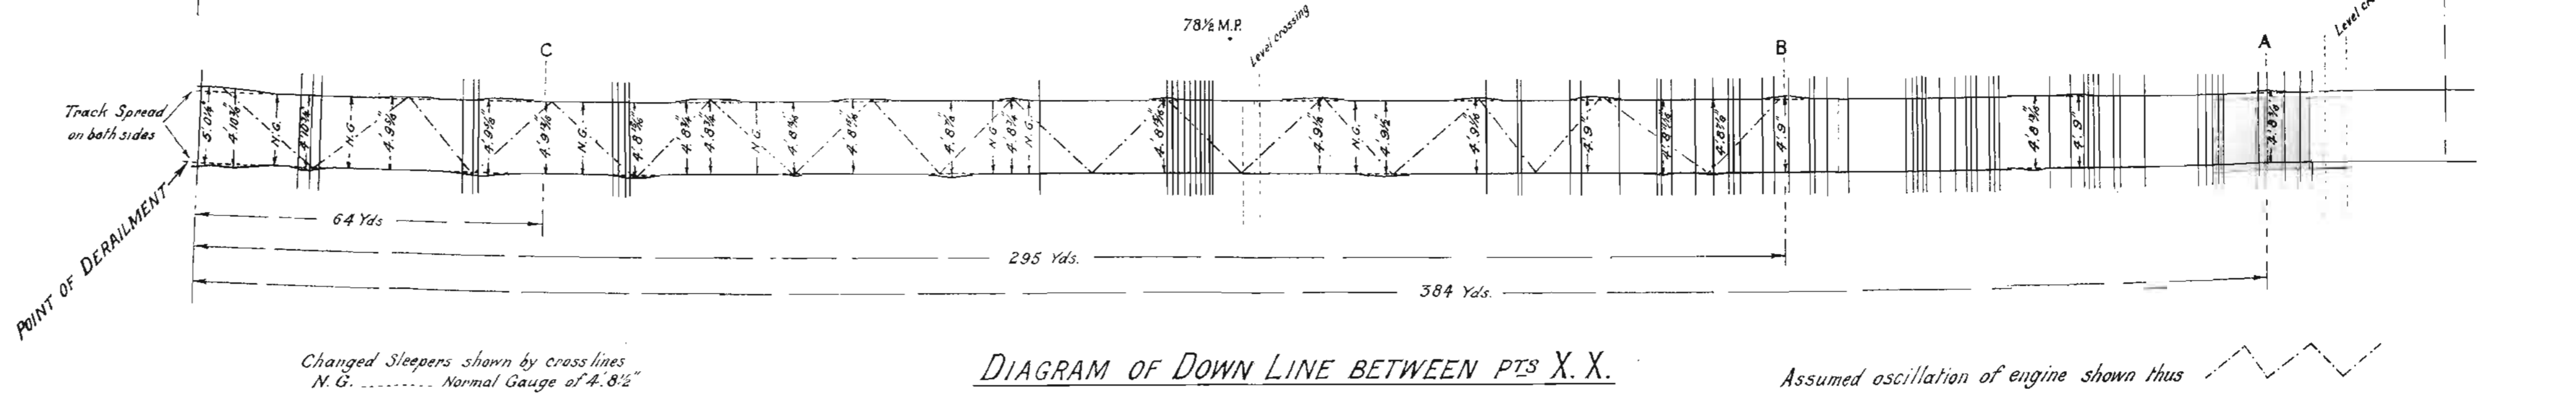
1. The attached plan shows the site of this accident, the position assumed by the engine and rolling stock, the damage to the track, and other relevant information.

left-hand rail. The first signs of widening of the gauge, as the result of the passage of this train, were noted at point A, about 380 yards in rear of the site, but between there and point B there was little evidence of this; as the fastenings appear to have been sufficiently stable, 33 sleepers, or 36 per cent., in this length having been recently changed. From point B, however, the pushing out of the chairs of one rail and then of the other, to the extent of $\frac{1}{2}$ inch to 1 inch, appears to have coincided with the side-to-side oscillation of the engine up to point C, 64 yards in rear of the site; thence the widening became rapidly worse until it reached $3\frac{1}{4}$ inches, fracture of the chair jaws of the left-hand rail indicating where derailment had commenced.
