MINISTRY OF TRANSPORT

REPORT ON THE DERAILMENT

11th February 1961

RUGBY (Central) and LUTTERWORTH
STATIONS

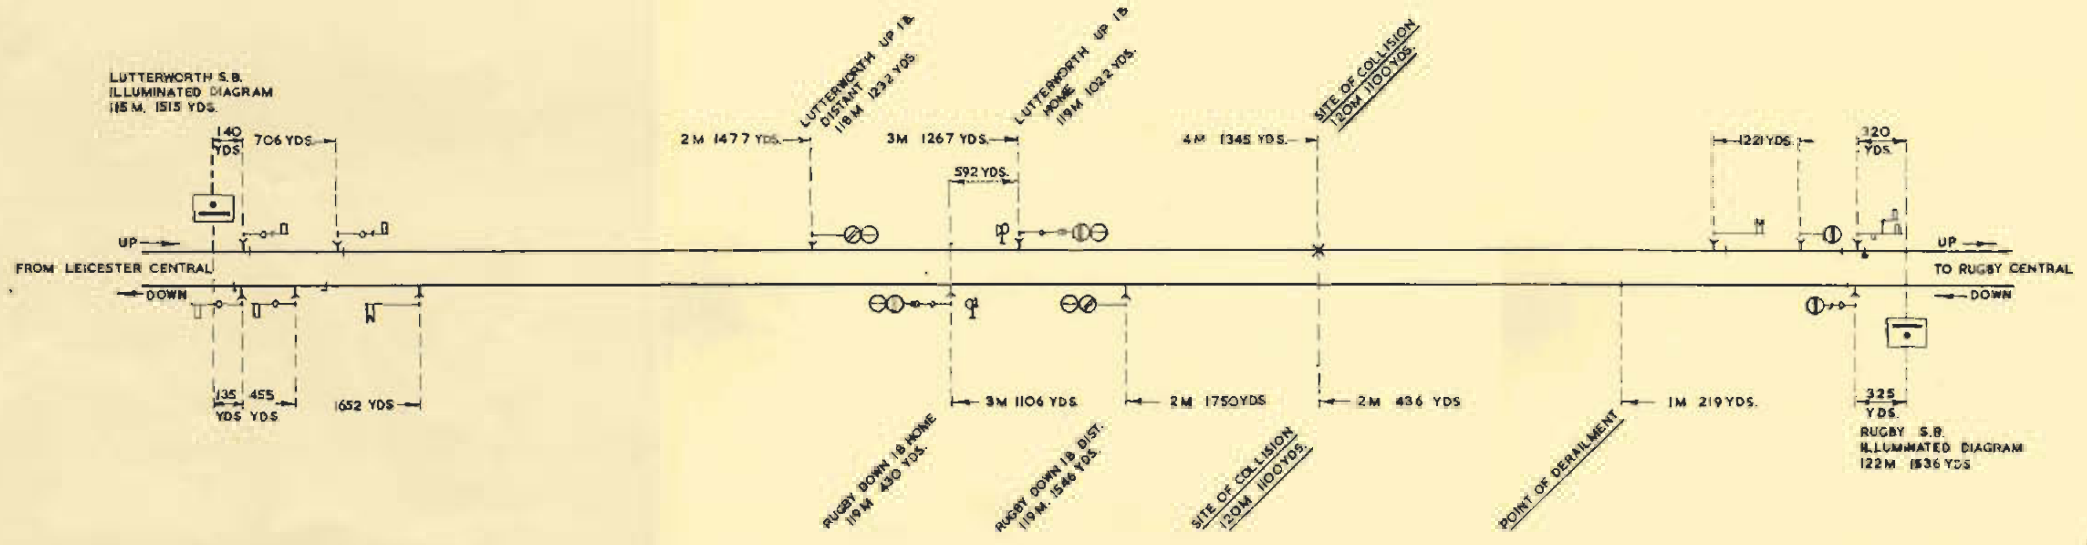
COLLISION AND DERAILMENT BETWEEN RUGBY AND LUTTERWORTH

until the levers in the boxes concerned have been replaced in the frame and thereafter pulled. Each signal box is equipped above its 40 lever frame with an illuminated diagram which shows the state of the track circuits, occupied or clear, and the aspects of the I.B. signals. Full block controls, including the Welwyn control, are provided; the "Block Release" control locks the lever for the I.B. home signal normal in the frame until the signalman has received line clear from the box ahead; he can, of course, always put the signal to danger at any time by replacing the lever in the frame, though having done so he cannot pull the lever again until he obtains another line clear. Telephones are provided at the I.B. home signals. The relevant distances between boxes, signals, the point of derailment and the site of the collision are shown on the diagram.

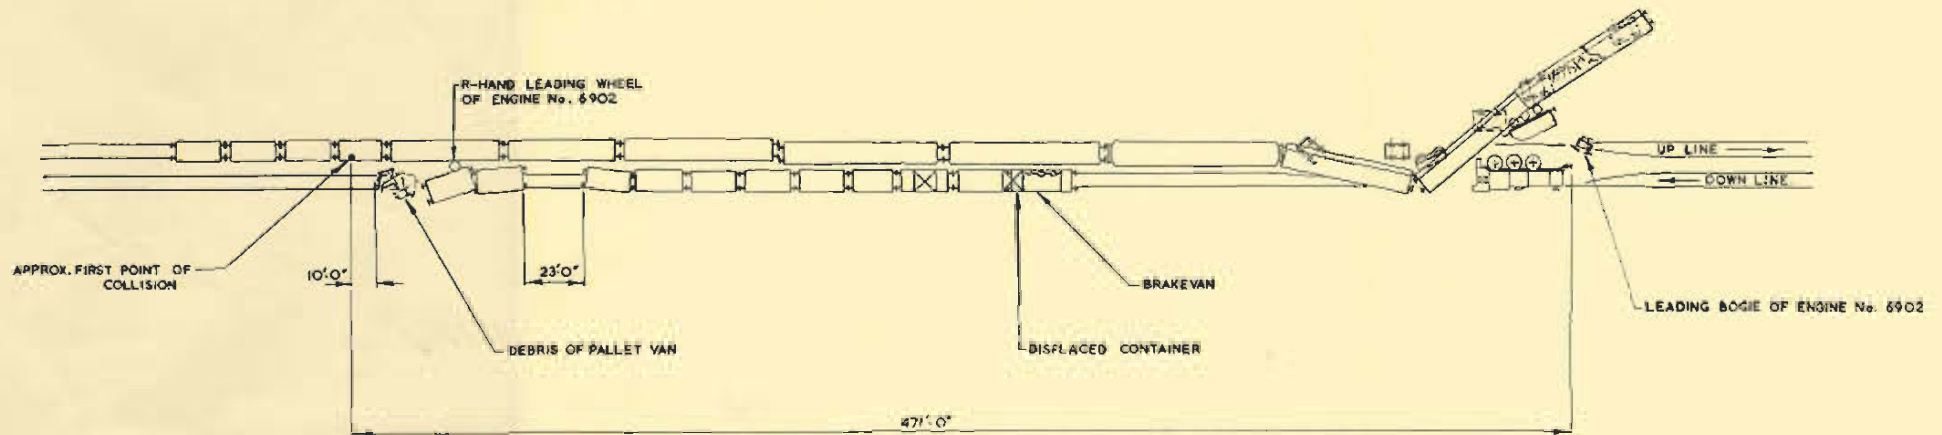
APPROXIMATE POSITION OF VEHICLES AFTER IMPACT

11. The front of the third vehicle followed the end of the second one on to the Down line, but the rear end remained over the Up line though the bogie was detached. The fourth vehicle, the first passenger one, remained in alignment though derailed, and the fifth and sixth were also completely derailed, as was the leading bogie of the seventh one. When the train came to rest the fifth vehicle was alongside the brake van of the freight train, and the ninth vehicle (the first of the 4-wheelers) was alongside the leading pallet van which had caused the collision. The position of the express train vehicles and of those of the freight train involved in the collision are shown on the sketch.
