## LONDON AND NORTH-WESTERN RAILWAY.

IN compliance with the instructions contained in your minute of the 8th instant, I have the honour to report, for the information of the Lords of the Committee of Privy Council for Trade, the result of my inquiry into the circumstances which attended the accident, that occurred on the 4th instant, near the Rugby station of the London and North-western Railway.

To accompany Captain TYLER'S Report, dated 30th July 1861, on the bursting of the Boiler of No. 249 Engine, attached to the Irish Mail Train, near Rugby, on the LONDON AND NORTH WESTERN RAILWAY, on the 4th July 1861.

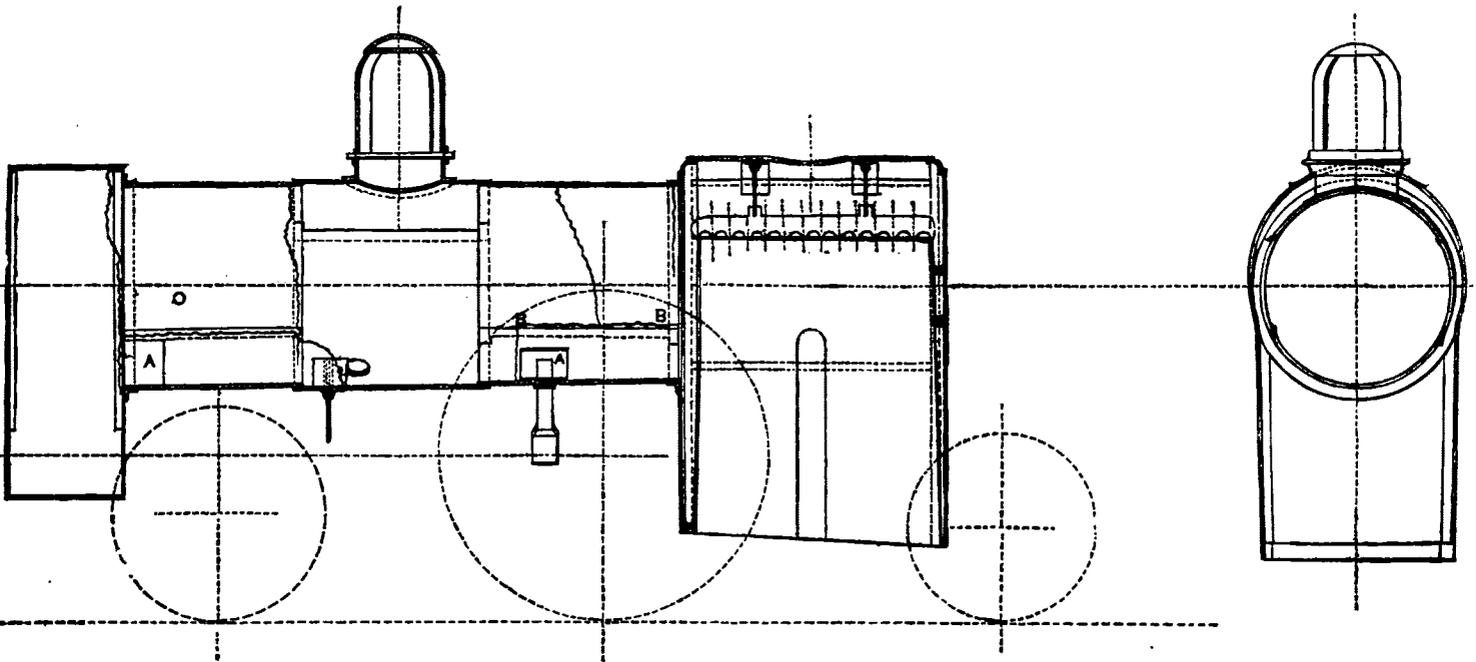
FIG. 1.

Those lines of fracture are clearly shown on the diagrams Nos. 1 and 2 enclosed herewith, the former having reference to the right, or off—the latter to the left, or near side of the engine. The different portions, also, into which the barrel of the boiler was divided, are shown in diagrams 3 to 9 inclusive; and the off driving wheel, with the portions that were blown away with it, in Nos. 10 and 11. These diagrams, which are interesting and important, in demonstrating the cause, and illustrating the effects of the explosion, have been kindly furnished to me by Mr. McConnell, the locomotive superintendent for the Southern division of the London and North-western Railway, and have been prepared by the officers of his department.

Longitudinal Section showing lines of fracture on right side.

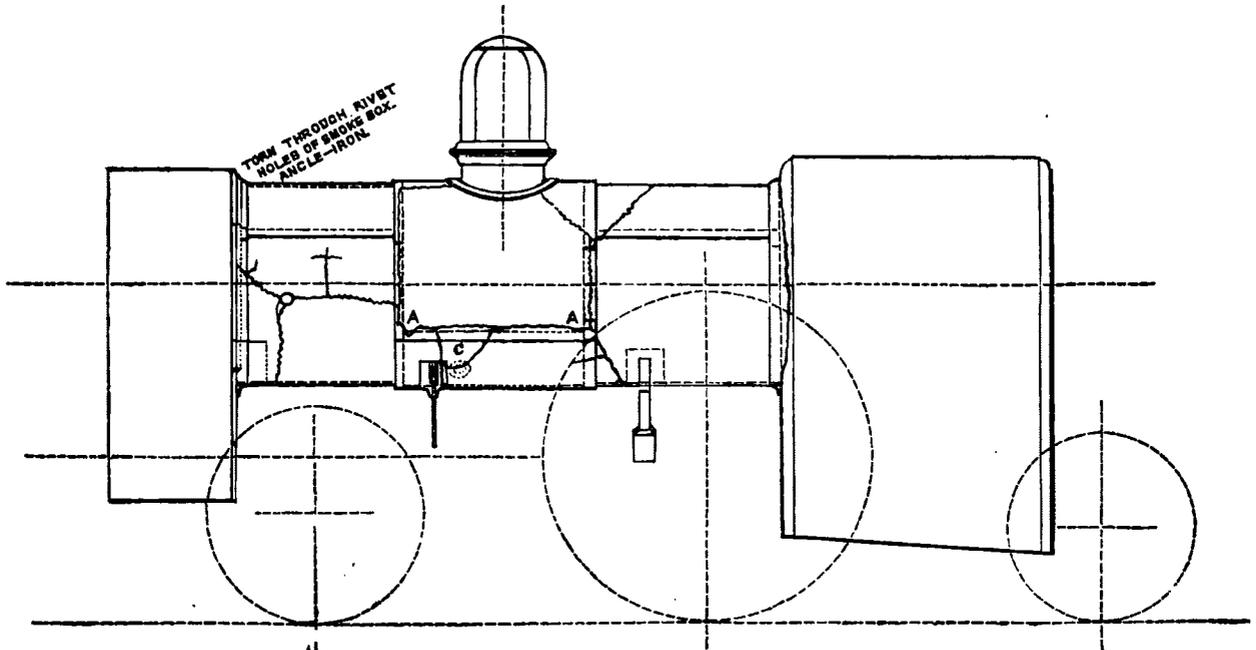
FIG. 2

Longitudinal Section showing lines of fracture on left side.

In examining the fractured portions of this boiler, I observed that corrosion had been actively going on in several parts of it, and particularly above two seams of rivets, the one situated on the left side of the middle ring, and marked A A in the diagrams Nos. 2 and 8; and the other on the right side of the firebox ring, marked B B in diagram No. 1. The former was the worse of the two lines, and was the weakest part of the boiler. The metal had been eaten away along this line in an irregular manner, and had been reduced in places, to little, if any, more than ⅙th of an inch, which, as I have before shown, would approach closely to the thickness at which rupture might be expected at the ordinary working pressure of the engine.

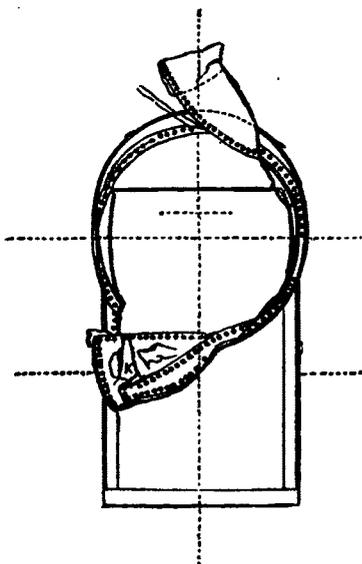
FIG. 3.

End elevation of fire-box, as seen from the front, with remains of fire-box ring attached.

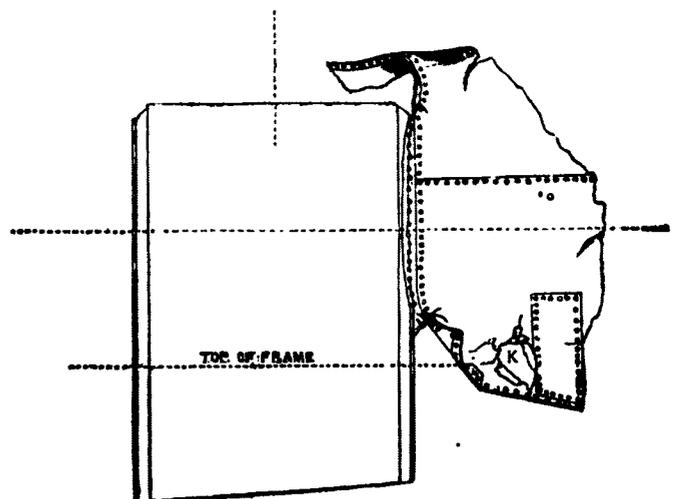
FIG. 4.

A ragged elongated hole had been made in the bottom of that part of the barrel of the boiler which remained on the fire-box, in consequence, evidently, of its having been penetrated by the left arm of the right crank, either after the fracture of the crank-axle, or at the time when it gave way; but this hole was an isolated one, and was totally unconnected with any of the numerous lines of fracture into which the boiler had been divided.

Side view of fire-box, and remains of fire-box ring of barrel.

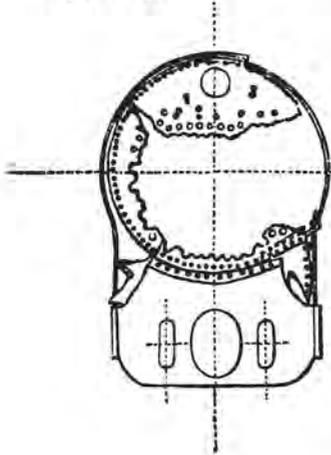
FIG. 5.

End view of smoke-box, as seen from behind, with remains of tube-plate, and small portions of smoke-box ring of barrel.

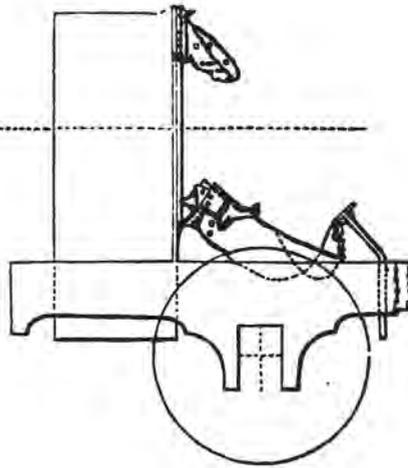
FIG. 6.

Side view of smoke-box, with portion of barrel attached.

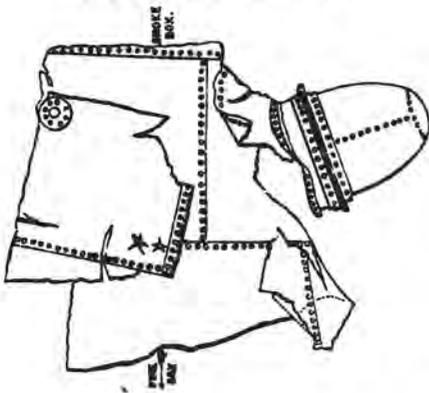
FIG. 7.

The barrel of the boiler was blown to pieces, while the fire-box remained almost uninjured. Of the three rings of which the barrel was composed, the middle ring, containing the steam-dome, was thrown off to the right in two pieces, and was separated from the remainder. It struck the south end of the right pier of the bridge with great violence, and knocked away a quantity of the brickwork. The larger portion of it, with the dome attached, after glancing off from the end of the pier, (which was built on the skew), fell on the slope in a crumpled condition, at 24 feet from the pier. The smaller portion, about 4' x 3', lay flattened between the larger portion and the bridge, somewhat lower on the slope, at eight feet from the pier, and almost under the right or east arch.

Larger detached portion of middle ring of barrel, with steam dome attached.

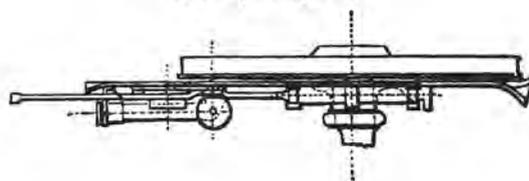
FIG. 11.

Plan and elevation of wheel and part of framing of No. 249 engine after explosion.
