LONDON AND NORTH-WESTERN RAILWAY.

Tamworth,
15th Sept. 1870.

SIR,
IN compliance with the instructions contained in your minute of yesterday, I have the honour to report, for the information of the Board of Trade, the result of my inquiry into the circumstances which attended the accident that occurred on that morning to the Irish mail train at the Tamworth station of the London and North-western Railway.

LONDON AND NORTH WESTERN RAILWAY.
SKETCH OF TAMWORTH STATION SHewing SITE OF ACCIDENT TO IRISH MAIL.

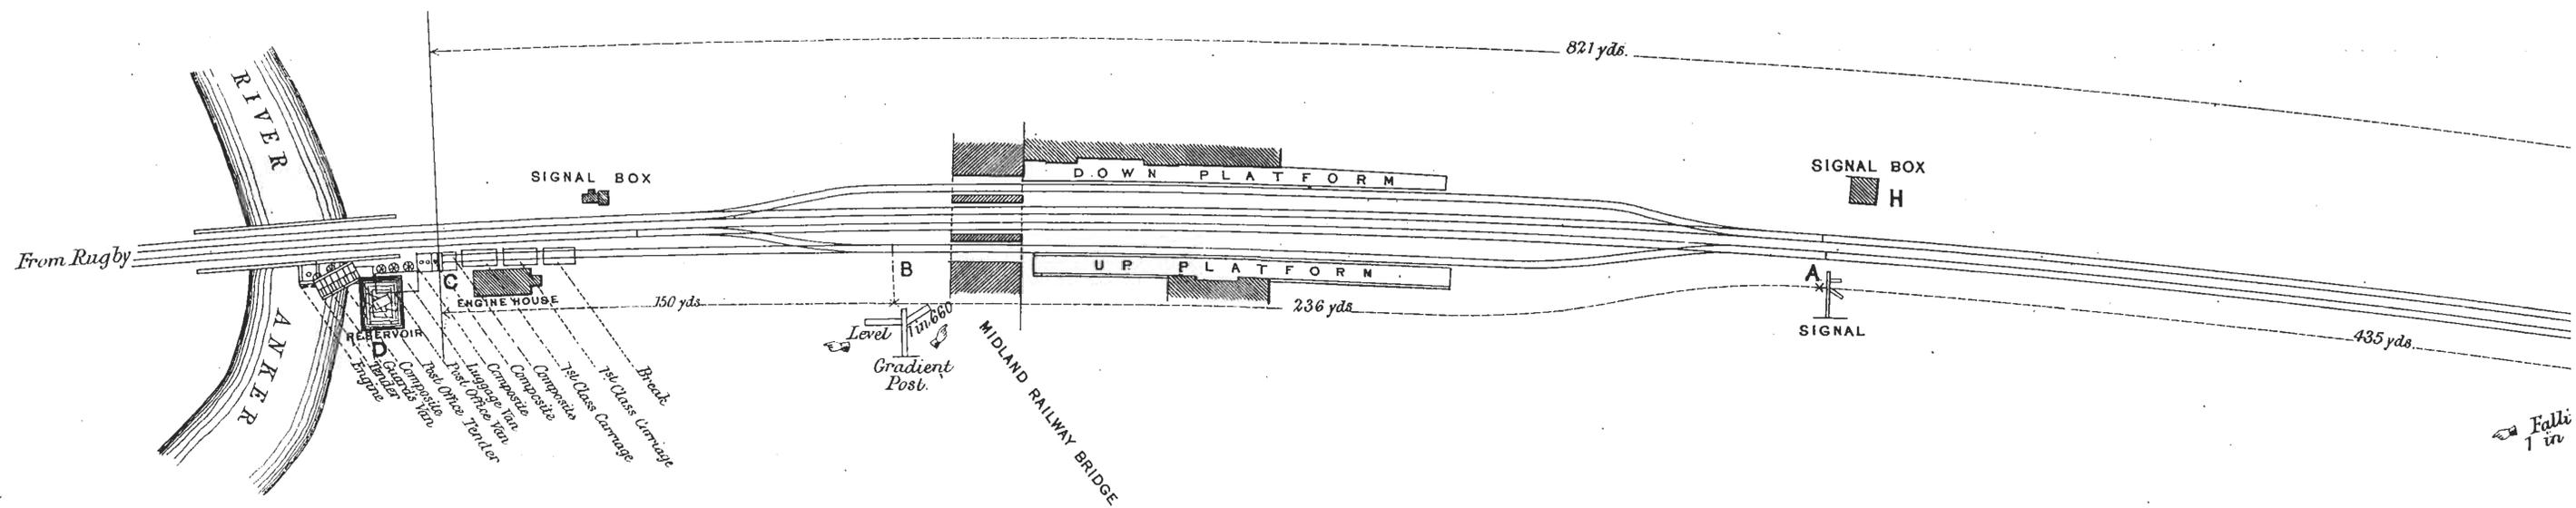
There are at Tamworth, as will be seen by the accompanying diagram, four lines of rails running through the station between the passenger platforms. Two of these lines are centrally situated, are separated from the platforms by the lines on either side of them, and are used exclusively for through trains not stopping at the station, and not requiring, therefore, to draw up at the platforms. The two outer lines are used for all stopping, both goods and passenger trains; and are loop lines, having connections with the through (centre) lines north and south of the station. The connection of the up through line with the up platform line is formed, on the north of the loop, by a pair of facing points (marked A in the diagram) 95 yards north of the north end of the up platform; and 236 yards to the south of these points (A) there are, 35 yards on the south of the south end of the platform, a pair of points (B) connecting the platform line with a siding. This siding, which is about 150 yards long from points to buffer stop, acts, when properly used, as a safety siding, to protect the through line from any engine or train moving out of the platform line, and is employed for waggons conveying fuel to a stationary engine there situated, which pumps up water to supply the locomotive engines, and for other purposes. At the end of this siding, about 150 yards from the points (B.) above referred to, which connect it with the platform line, there was a rough buffer stop (C), formed of earth and lined inside with timber; and beyond the site of this buffer stop, the river Auker, a tributary of the Tame, runs under a bridge which carries the two main lines of the railway towards London. On the north side of the river, and on the east of a line prolonged from the siding, there is a reservoir (D) for collecting and depositing the mud from the water pumped up by the stationary engine. This reservoir measures 40 feet long by 31 feet wide, and is 13 feet deep.

The immediate causes of this accident were, (1) the mistake of the signalman at the north cabin, in setting his points in the wrong direction, and turning the Irish mail train into the platform line in place of the through line, (2), the want of sufficient warning to the engine-driver of the mail train to enable him to stop short of those points when they were set in the wrong direction, and (3) the want of extra locking mechanically between the south and north signalman, to prevent the possibility of the fatal mistake which was made by the latter.

The third cause has reference to the incompleteness of the locking arrangements, with regard to the plan of the station and the conditions of the traffic. It will be remembered that the south signalman, working a lever at his own station, turned over a disc in the north cabin to show that the through line was clear for the Irish mail train, before the arrival of that train, and that the disc lever so worked at his own station locked the siding points for the siding. He thus, in making it safe for a train to pass the station on the through line, made it dangerous for a train to pass through on the platform line; and in so doing he acted independently of the signalman in the north cabin, as far as locking was concerned; and he moved the north cabin disc for the through line, not when the Irish mail train was approaching, but 16 minutes previously, when it might have been expected. For the whole of those 16 minutes, therefore, the points (A) lay open for the platform line, while the points (B), lay at the same time open for the siding, and the two signalmen combined, in this manner, acting independently of each other, to cause the accident, and to wait in this joint position of imminent danger for 16 minutes until it occurred. If, on the other hand, the south signalman had been provided with the means of locking the points (A) for the through line while the points (B) were thus locked for the siding, and while he turned on the disc to show "all right" for the through line, and if he had been unable to show all right for the through line except by working the points against the platform line, or if, in other words, the north signalman had been prevented from admitting a train to the platform line unless the points (B) had been locked for the through line in place of for the siding, the accident could not then have occurred.

enable an engine-driver to bring his engine or train to a stand, when from a mistake of the signalman or from any other cause they are not set right for him; that the interlocking should be carried out on a complete system, so as to avoid conflict of points and signals between two signalmen at the same station; that the signalmen should be amply warned by telegraph of the approach of non-stopping and indeed of all trains; and that they should be provided with the means of ascertaining in their cabins the correct time.
